METEOROID AND DEBRIS IMPACT FEATURES DOCUMENTED ON THE LONG DURATION EXPOSURE FACILITY

A Preliminary Report

Compiled by Members
of the LDEF Meteoroid
and Debris Special
Investigation Group

Space & Life Sciences Directorate
Solar System Exploration Division
Planetary Science Branch
Publication # 84
JSC # 24608

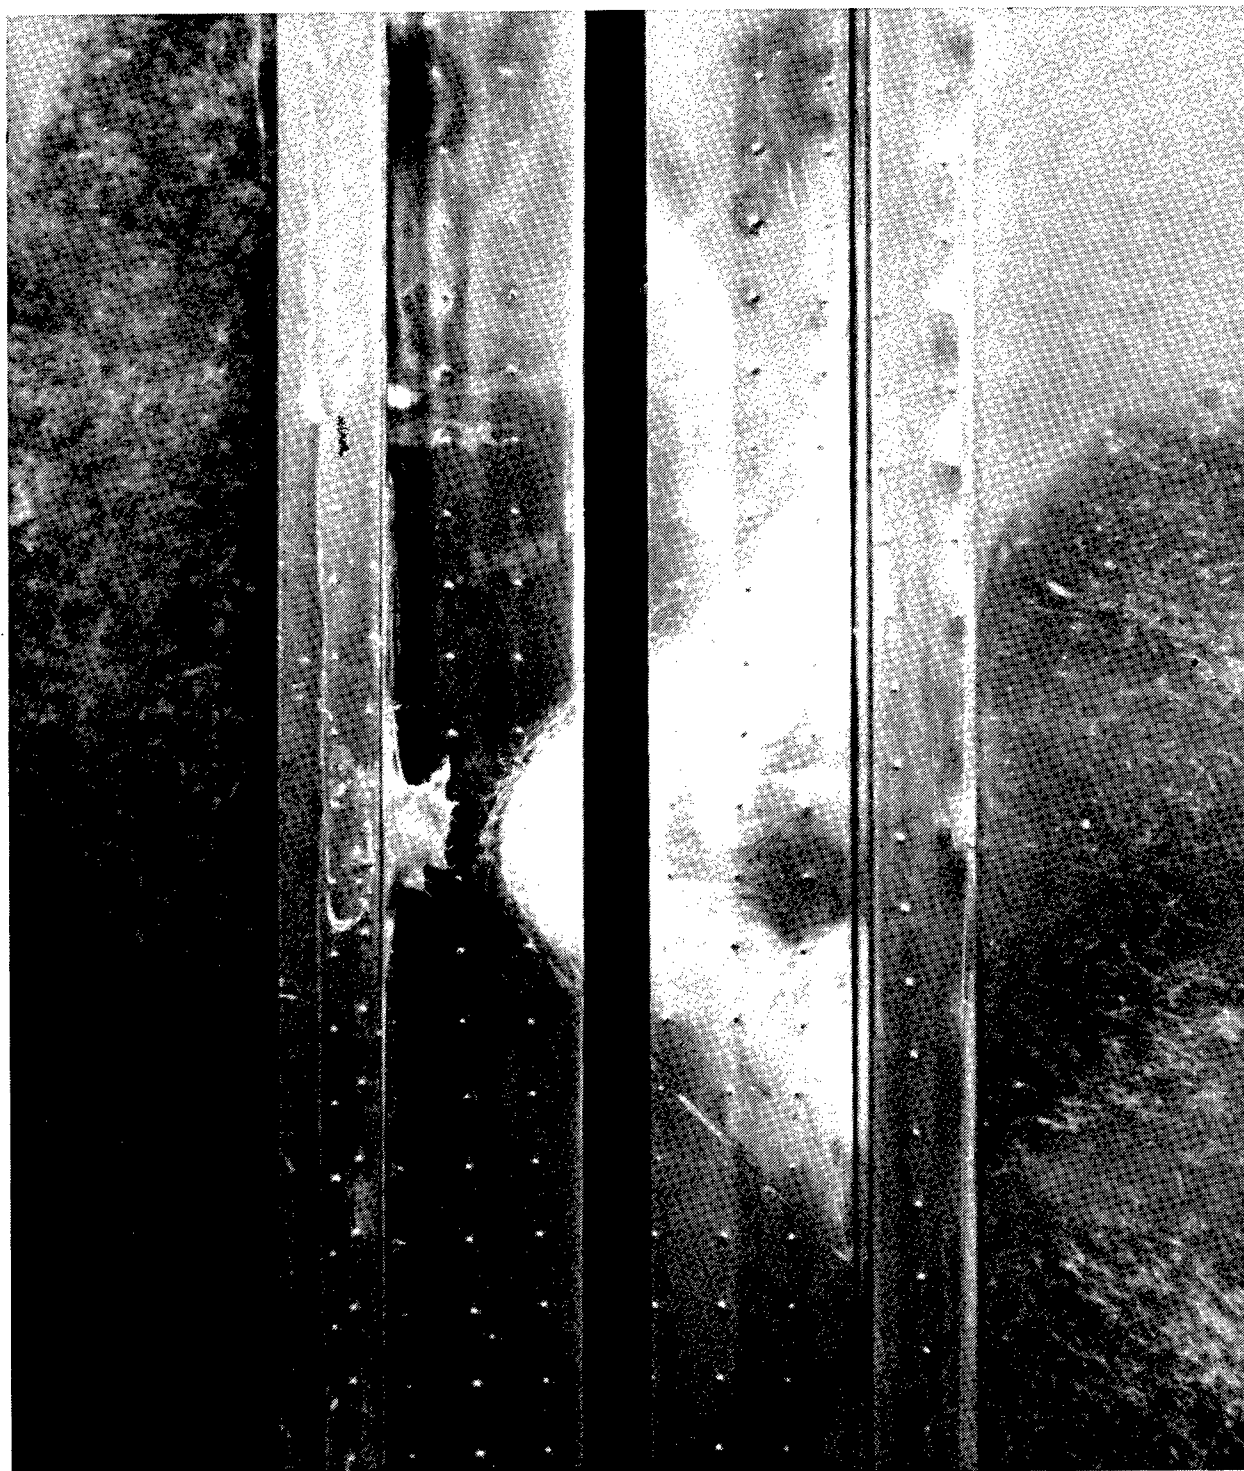
Figure H03-3. This is a side view of the largest impact feature on LDEF (LE000007.H03). The impactor hit the right side of the aluminum Z-frame on the left (Module "A"), and ejecta was deposited across the intervening space to the adjacent Z-frame on the right (Module "D"). This view measures approximately 10 cm across.

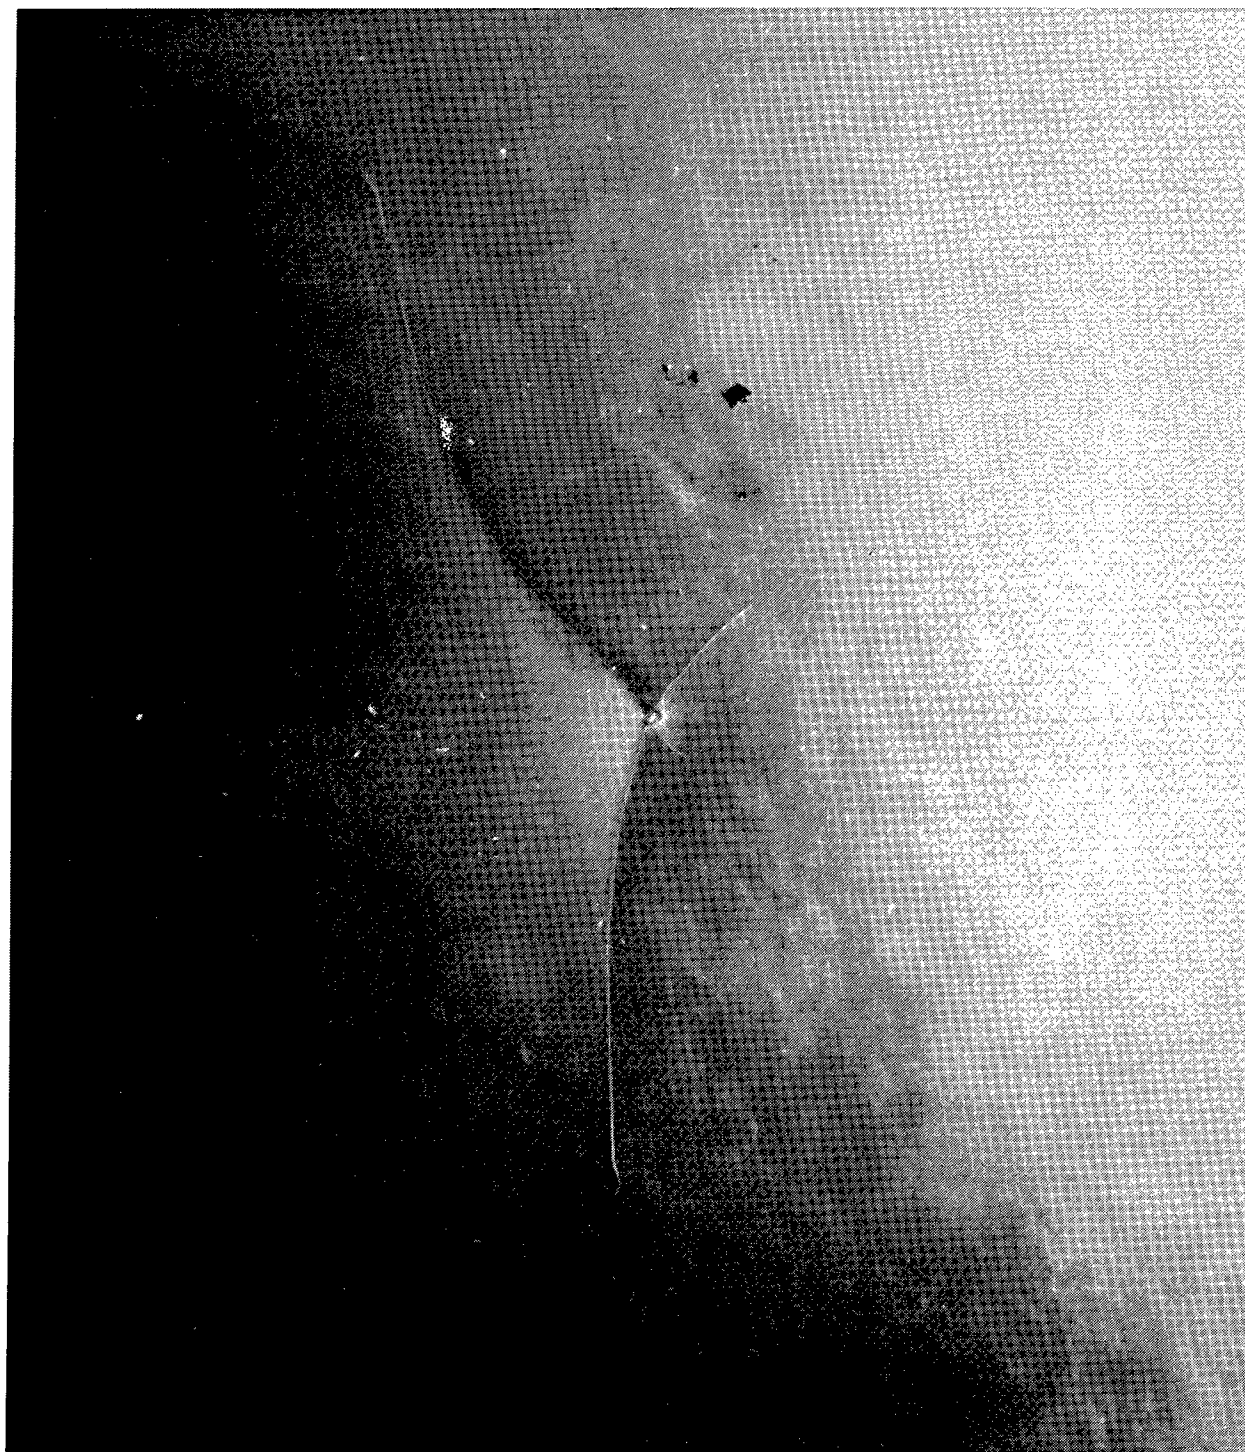
back on orbit, impact features were apparent in the lexan detector stacks. Some impact features were accompanied by cracks (e.g., Detector "D"). No impacts were noted in the portions of the lexan detectors which were still shielded by the multi-layer blankets.

Figure H03-4. This view shows an impact penetration located in lexan detector stack "D", in a place where the thermal blanket had peeled back and exposed the lexan to the particulate environment. The impact penetrates eight layers of lexan, but the large crack only effected the top-most layer. This view measures approximately 8 cm across.

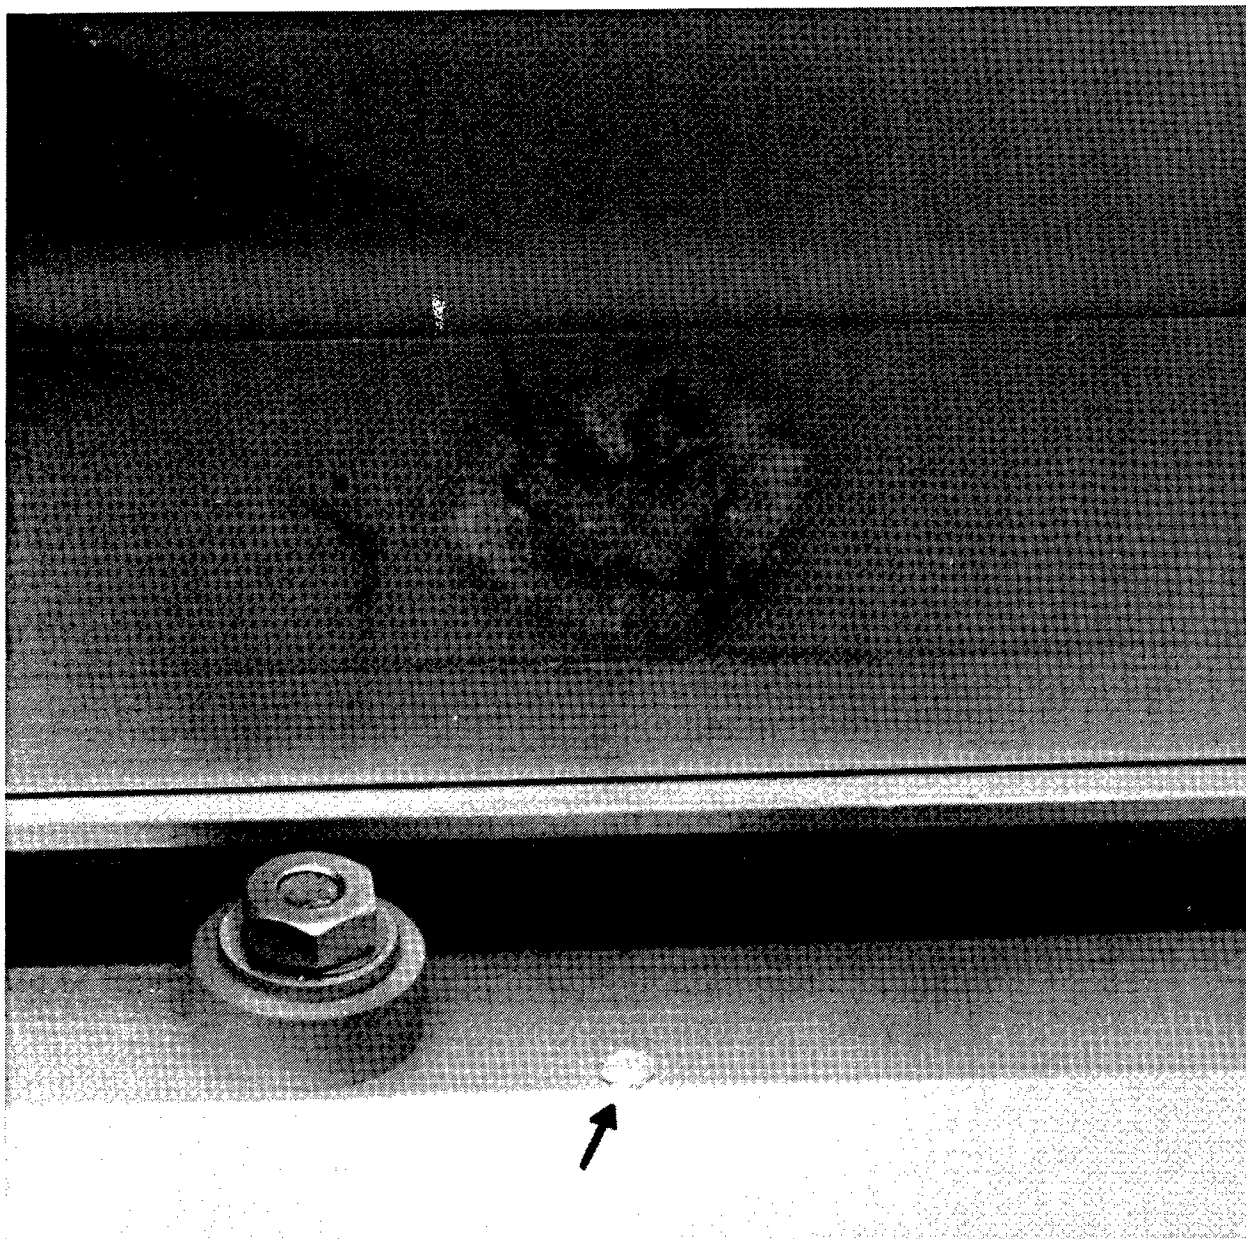
Figure H09-2. View of a crater (indicated by arrow) located in aluminum with a large adjacent ejecta pattern. The feature was located inside one of the detector housings. This view measures approximately 12 cm across.

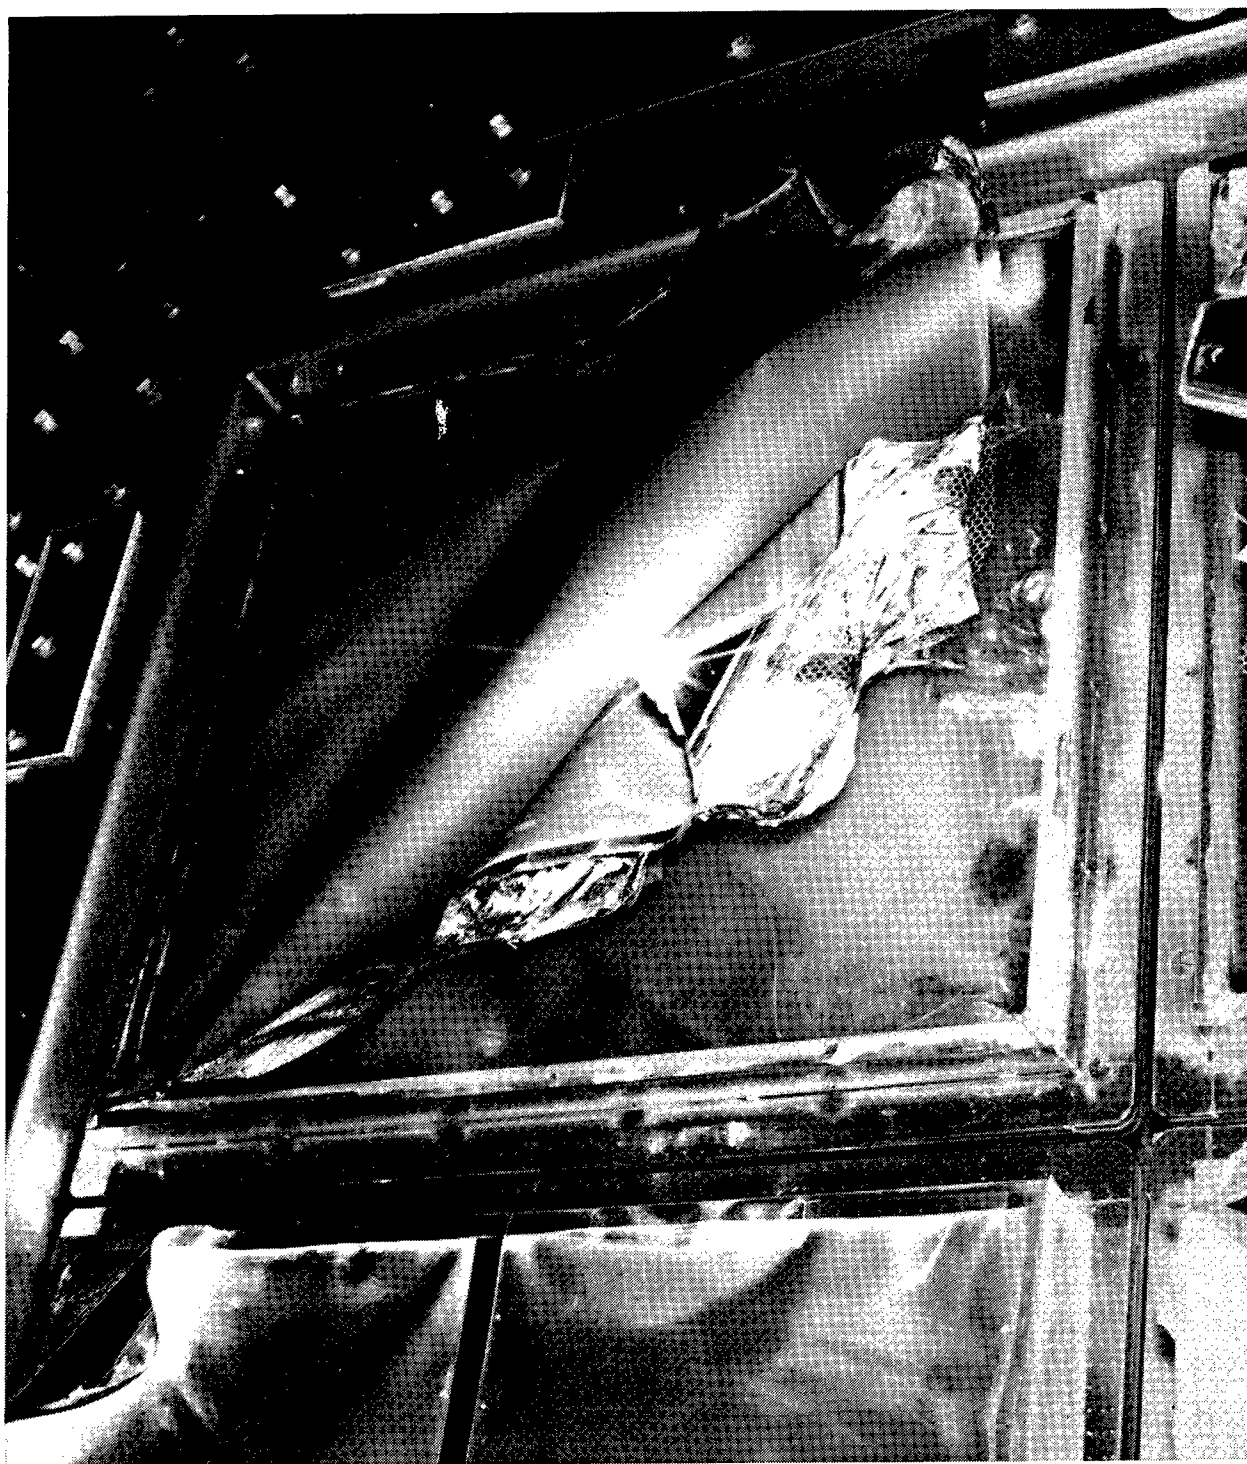
Figure H12-2. This pre-deintegration view shows one module of tray H12 with the thermal blanket partially peeled back exposing the lexan detector stack below.

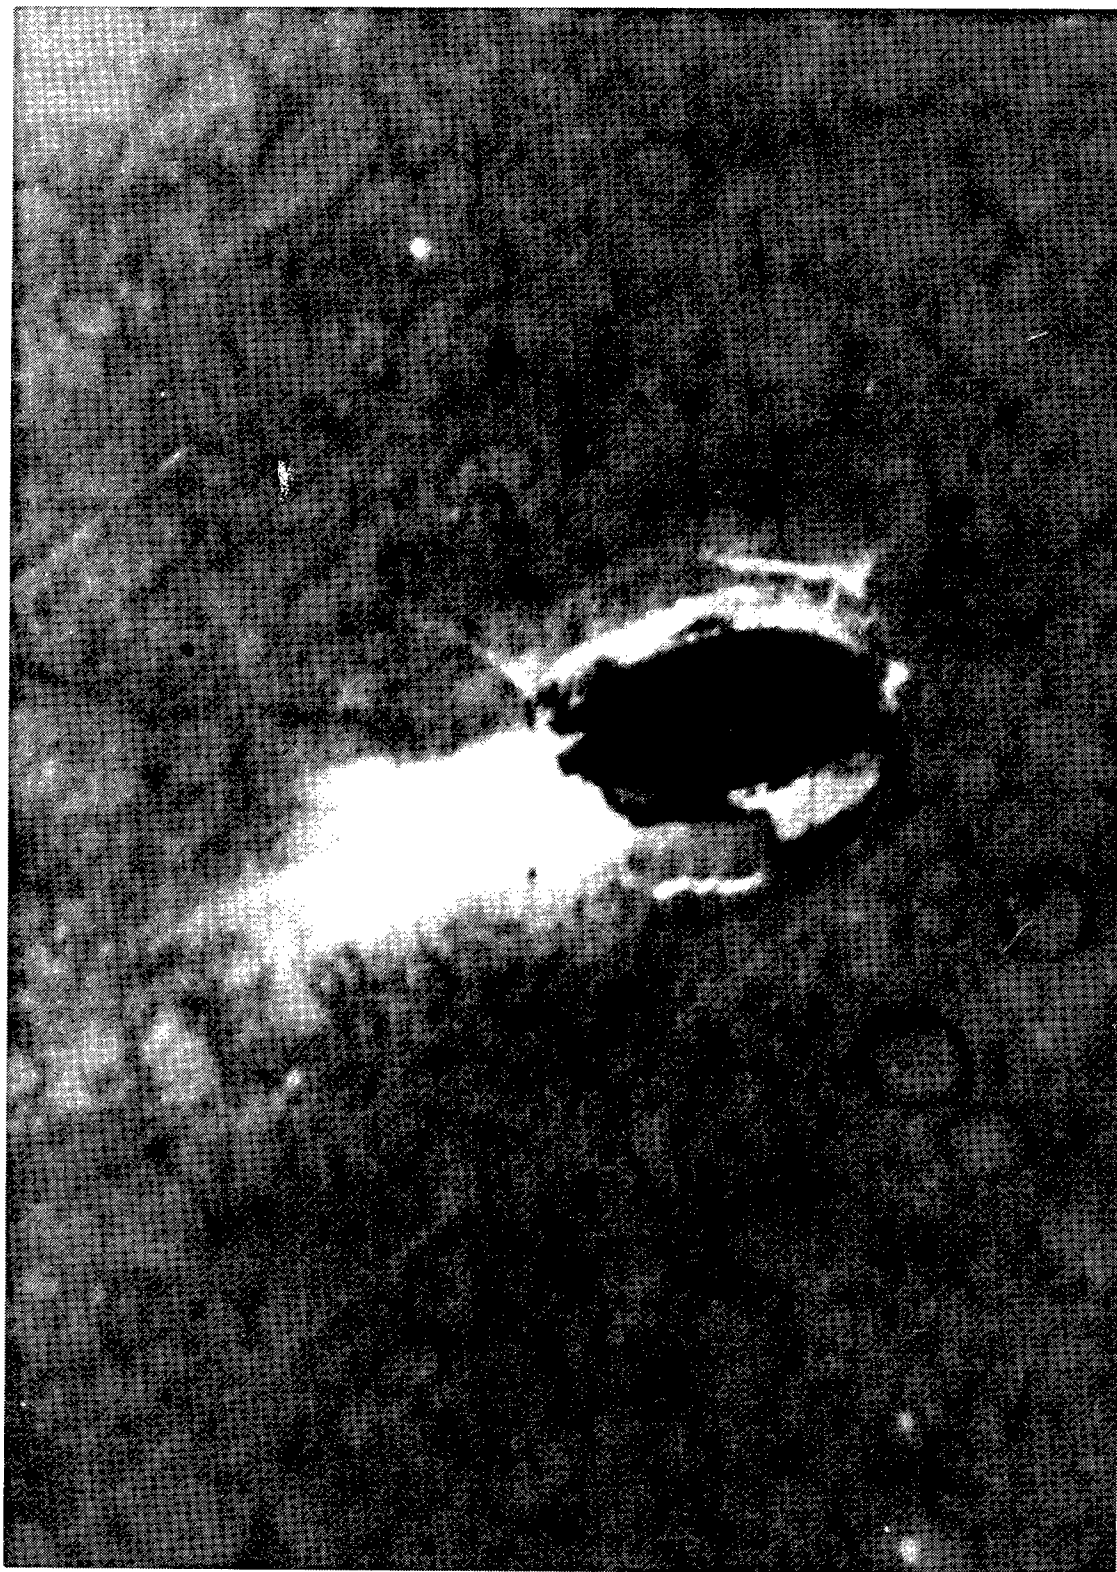
Figure H12-3. This is a view of a penetration hole through one of the H12 multi-layer thermal blankets. The streak adjacent to the hole may be indicative of an oblique impact. View measures ~2 cm across.

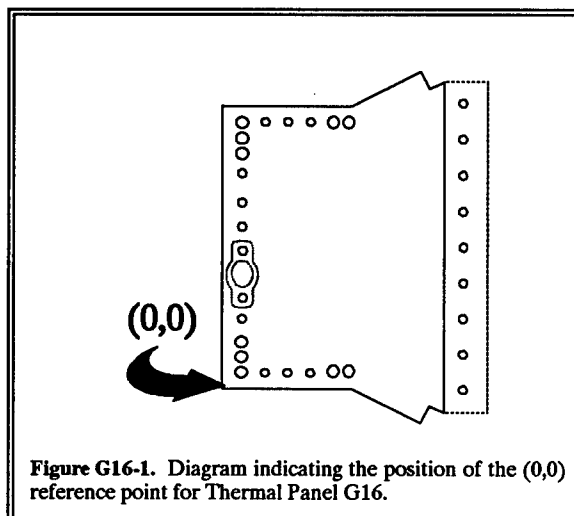
Figure G16-1. Diagram indicating the position of the (0,0) reference point for Thermal Panel G16.

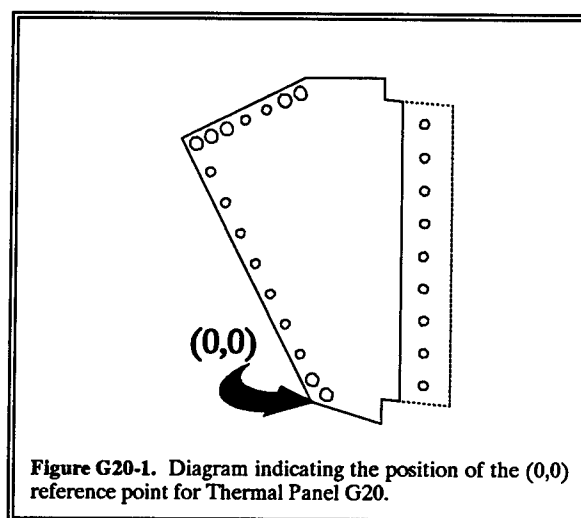
Figure G20-1. Diagram indicating the position of the (0,0) reference point for Thermal Panel G20.

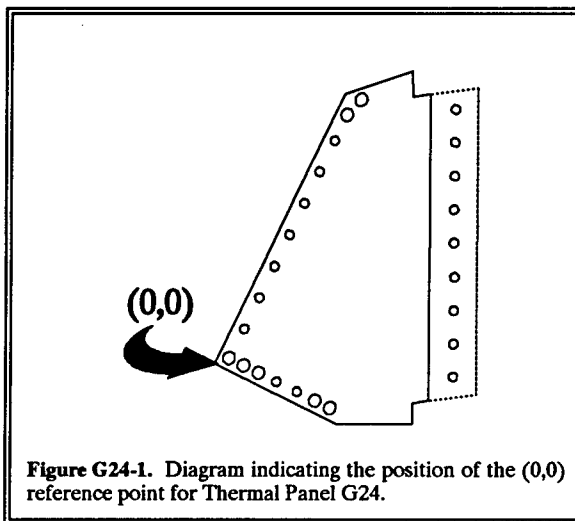
Figure G24-1. Diagram indicating the position of the (0,0) reference point for Thermal Panel G24.

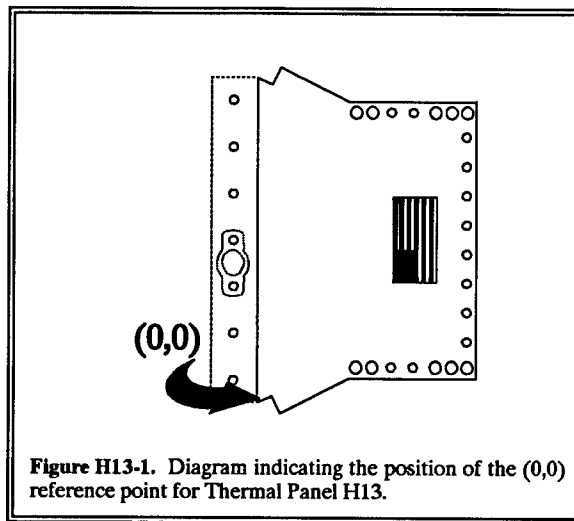
Figure H13-1. Diagram indicating the position of the (0,0) reference point for Thermal Panel H13.

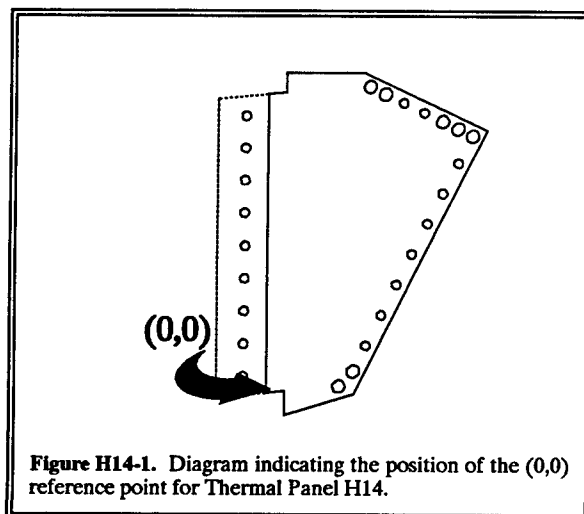
Figure H14-1. Diagram indicating the position of the (0,0) reference point for Thermal Panel H14.

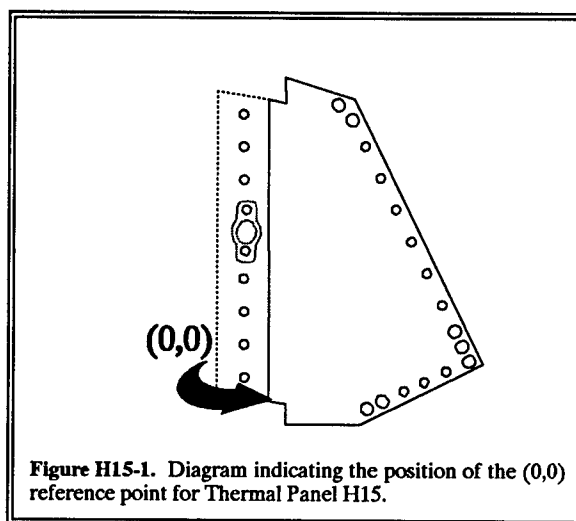
Figure H15-1. Diagram indicating the position of the (0,0) reference point for Thermal Panel H15.

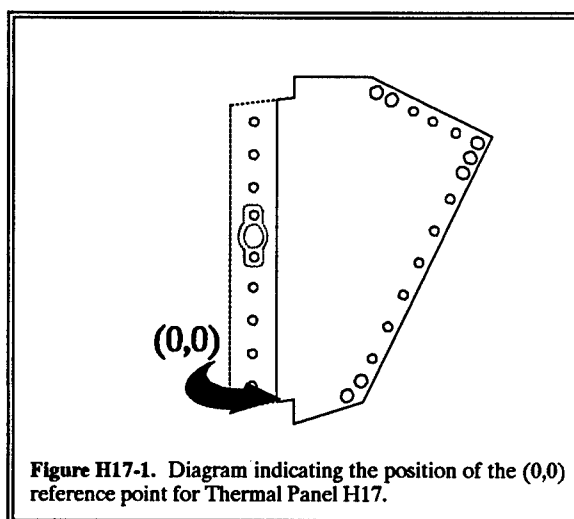
Figure H17-1. Diagram indicating the position of the (0,0) reference point for Thermal Panel H17.

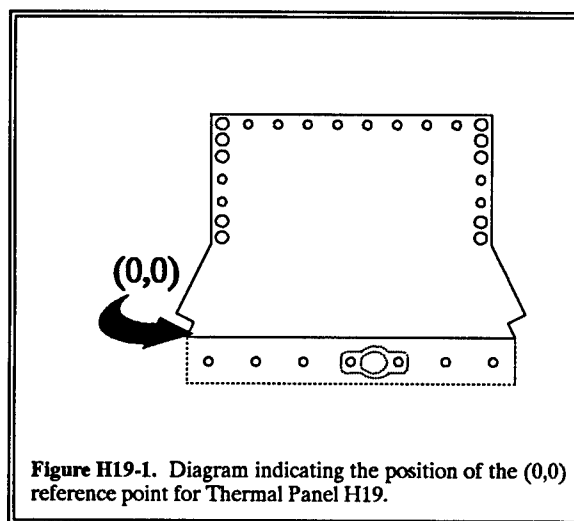
Figure H19-1. Diagram indicating the position of the (0,0) reference point for Thermal Panel H19.

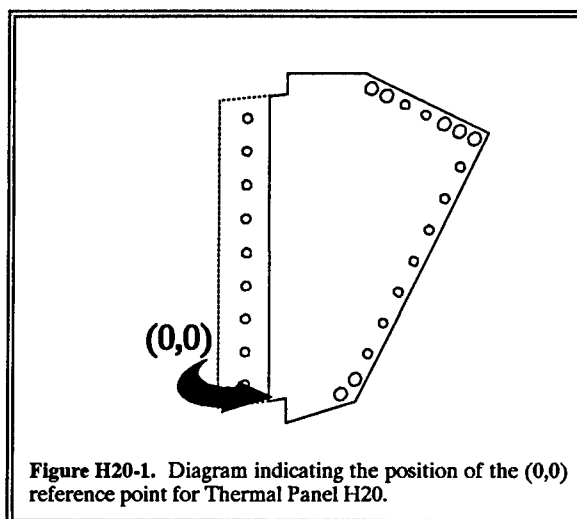
Figure H20-1. Diagram indicating the position of the (0,0) reference point for Thermal Panel H20.

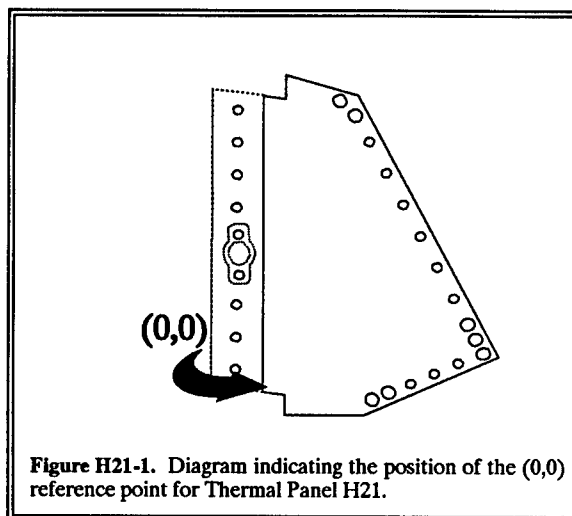
Figure H21-1. Diagram indicating the position of the (0,0) reference point for Thermal Panel H21.

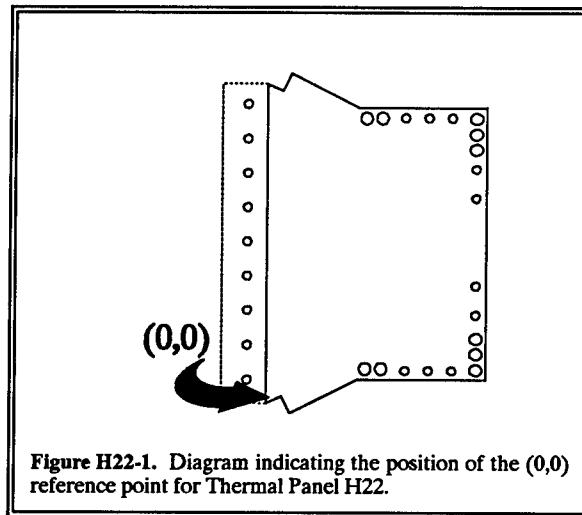
There were no noticeable penetrations, bulges, or spallation features on the front of the 0.0625" (1.6 mm) thick thermal control panel. However, there were four noticeable bulges and black paint spallations on the back of the thermal control panel.

2 - Spalled black thermal control paint from back surface.

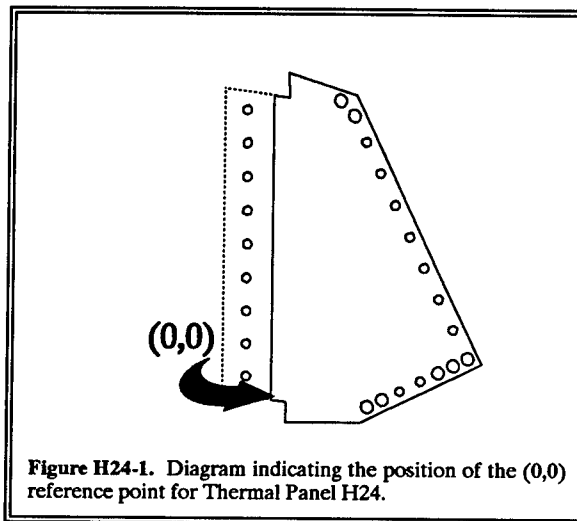
Figure H24-1. Diagram indicating the position of the (0,0) reference point for Thermal Panel H24.

Detailed examination of Thermal Panel H24 revealed 133 features, 116 of which were <0.5 mm in diameter and were not photodocumented (64 on the space-facing component and 52 on the Row 11-facing strip). Of the 17 remaining impacts 11 resided on the space-facing component and ranged in size from 0.6 mm to 1.6 mm the latter being the largest impact found on the space-facing component of thermal panel H24. The six imaged impacts residing on the Row 11-facing strip ranged in diameter from 0.5 mm to 1.7 mm with the latter being the largest impact found on thermal panel H24. None of the highly-oblique features observed by the M&D SIG A-Team on the various Earth-end thermal panels were discovered on the space-end thermal panels while at KSC. A more detailed, microscopic examination of the space-end thermal panels is being conducted at LaRC in search of highly-oblique features. Morphologically, the craters examined on this thermal-control panel were typical of impact craters formed in similar material under controlled, laboratory conditions.

There were no noticeable penetrations bulges, or spallation features on the 0.062" (1.6 mm) thick thermal control panel.

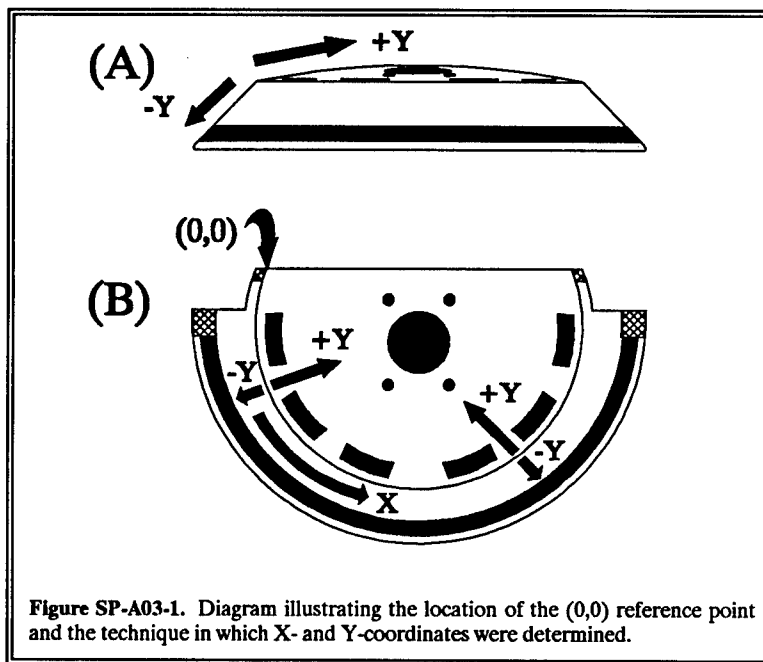
There were no noticeable penetrations, bulges, or spallation features on the front or back of the A03 scuff plate.

- 1 - Impact into black-painted area on front face.
- 2 - Higher magnification view of feature LG020002.A03.
- 3 - Spall zone present, but little or no penetration into aluminum substrate.
- 4 - Crater in aluminum substrate not centered in associated spall zone.

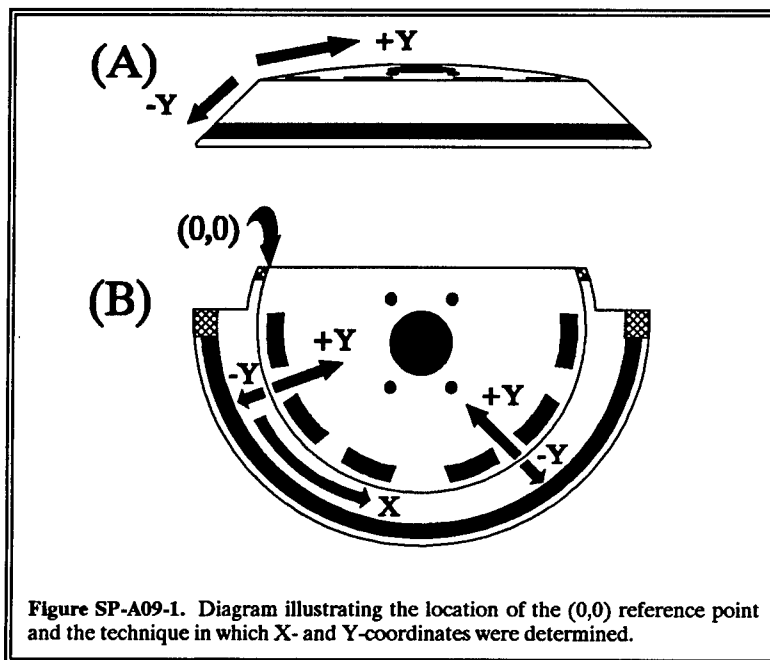
Figure SP-A09-1. Diagram illustrating the location of the (0,0) reference point and the technique in which X- and Y-coordinates were determined.

There were no noticeable penetrations, bulges, or spallation features on the front or back of the A09 scuff plate.

1 - Spall zone associated with crater. Machine lines visible in aluminum surface below paint.

2 - Large double spall around crater.

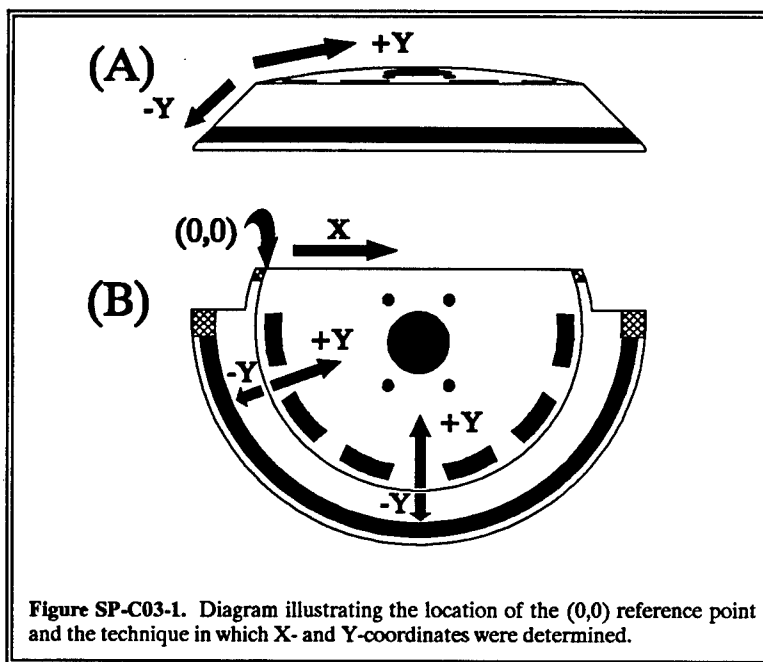
Figure SP-C03-1. Diagram illustrating the location of the (0,0) reference point and the technique in which X- and Y-coordinates were determined.

The M&D SIG survey of Scuff Plate C03 identified and photodocumented seven impact features < 0.5 mm in diameter on all scuff-plate surfaces, four of which were located on the hemispherical main face, and three which were located on the ~ 4 " (10.2 cm) skirt. One additional feature on the skirt area of this scuff plate was identified, but not photodocumented. Morphologically, all features examined were typical of craters produced in painted aluminum surfaces under controlled laboratory conditions (*i.e.*, craters were generally surrounded by front-surface spall zones in the paint layers). As the paint was in several layers on these scuff plates, it was not unusual to find the diameter of the associated spall zone to vary from layer to layer.

There were no noticeable penetrations, bulges, or spallation features on the front or back of the C03 scuff plate.

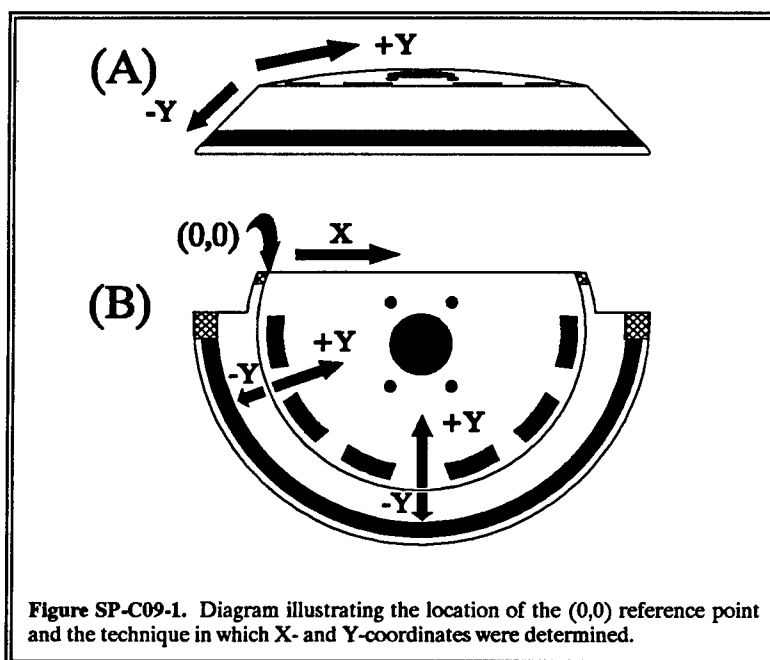
Figure SP-C09-1. Diagram illustrating the location of the (0,0) reference point and the technique in which X- and Y-coordinates were determined.

The largest features identified on Scuff Plate C09 were (1) an ~ 1.0 mm diameter feature and (2) an elliptical feature measuring $\sim 0.5 \times 0.7$ mm, both of which were on the skirt area of the scuff plate. The largest spall zone area measured ~ 2.2 mm in diameter and was associated with an ~ 0.4 mm diameter crater.

There were no noticeable penetrations, bulges, or spallation features on the front or back of the C09 scuff plate.

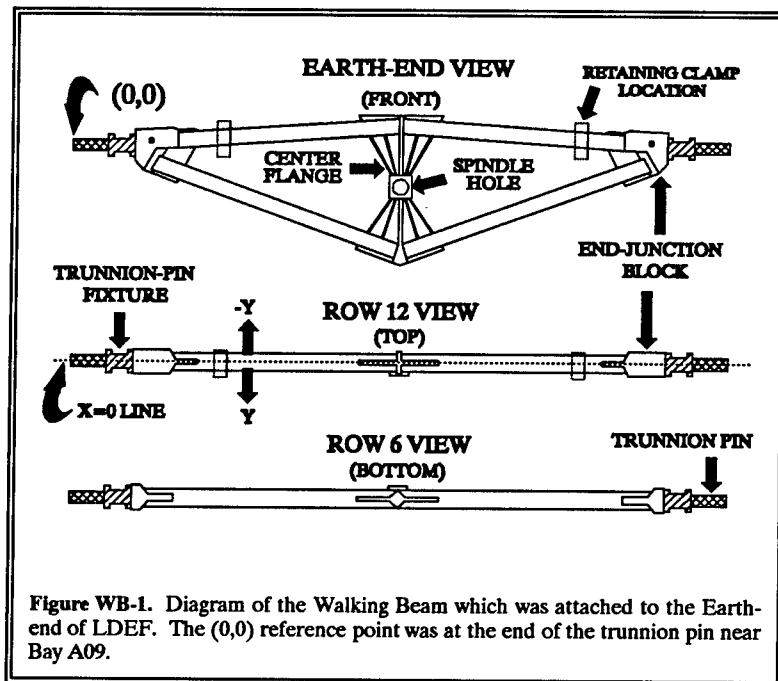
The M&D SIG survey of the Walking Beam and its associated hardware identified a total of 35 impact features. Twenty five of the 35 features were <0.5 mm in diameter (two of which were located on the plate covering the spindle hole, two were located on the Row 3 trunnion-pin fixture, two were located on the retaining clamps [one on each], and 19 on the Walking Beam). Of the remaining ten features, nine were between 0.5 mm and 1.0 mm in diameter (eight on the Walking Beam [one of which was an elliptical feature measuring ~0.8 x 1.3 mm in size] and one on the spindle-hole cover plate), and one was ~1.3 mm in diameter and was located on the retaining clamp near Bay G03. No impact features were identified on any of the bolts associated with the Walking Beam. Morphologically, all features were typical of craters produced in aluminum under controlled laboratory conditions.

There were no noticeable penetrations, bulges, or spallation features on the Walking Beam or its associated hardware.
